The Downward Path to Broadcast Engineering—No. 29

A big transmitter, a shorted transformer, and no money for a replacement—what to do?

By Joseph M. Davis, P.E.
President
Chesapeake RF Consultants, LLC

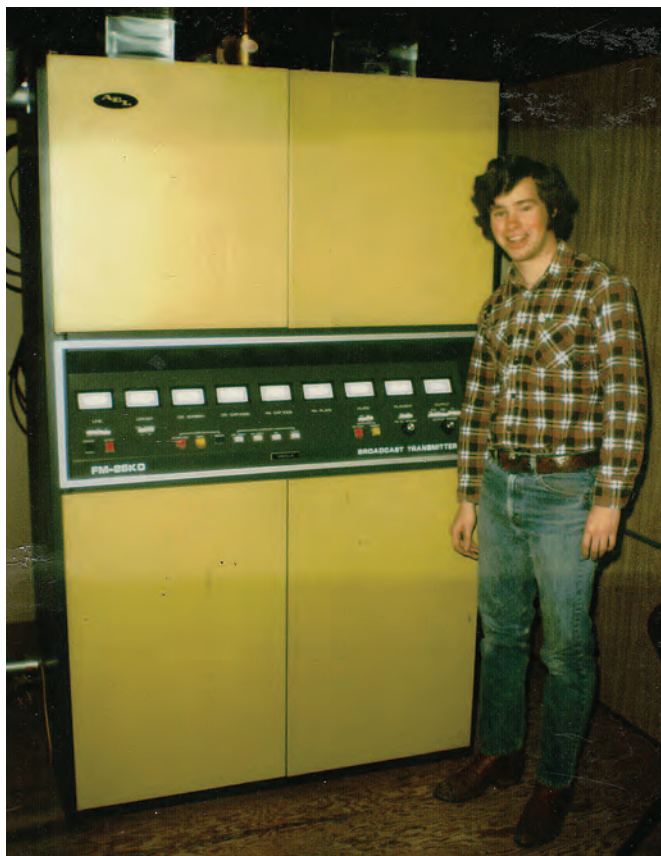
A 21-year-old Davis with the big AEL FM25KD and its even bigger power supply problems.
